CECOM-TR-01-5

The Basis of Conventional Lightning Protection Technology

A review of the scientific development of conventional lightning protection technologies and standards.

Report of the Federal Interagency Lightning Protection User Group June 2001

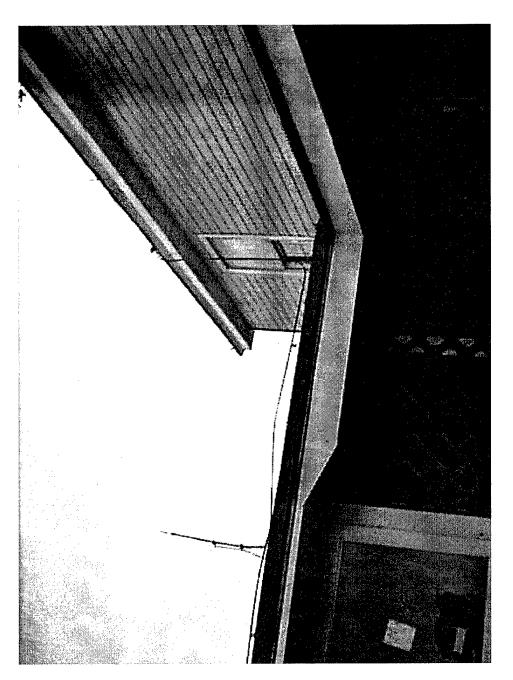
Figure 2. South View of Farm House lower level air terminal. Note there is no air terminal provided for attachment to the chimney would likely cause it to fracture, while lightning to the antenna would likely the chimney and TV antenna. An attachment to either could prove very damaging. A lightning be transferred to the structure of the house and enter through the lead in wire.

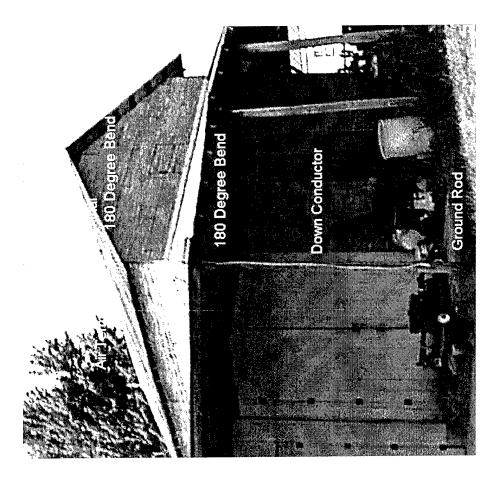
Figure 6. Example of lightning protection system on farm shop structure. Two 180 degree bends were formed in the northern down conductor. Testing and field experience reveals that this will fail during a lightning strike, causing a high temperature spark which could ignite the structure.

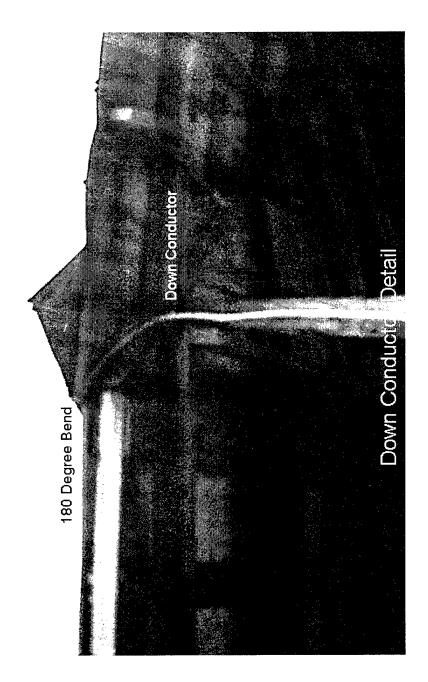
Figure 7. Detail of 180 degree bend on farm shop.

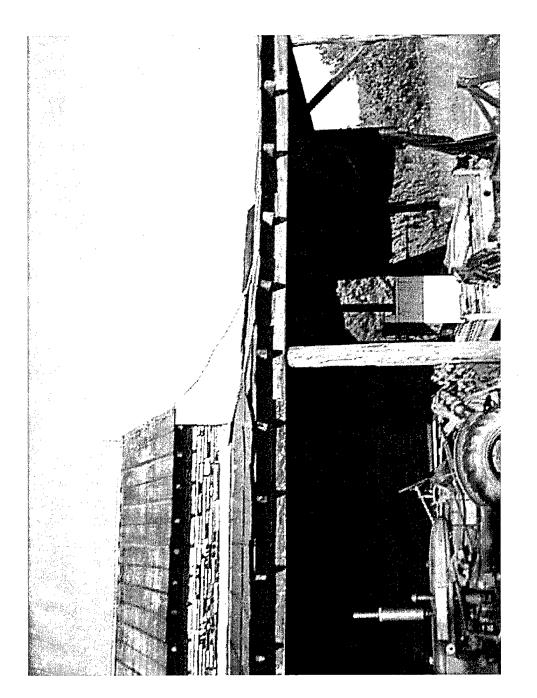
Figure 8. Example of improper conductor support due to lack of system maintenance.

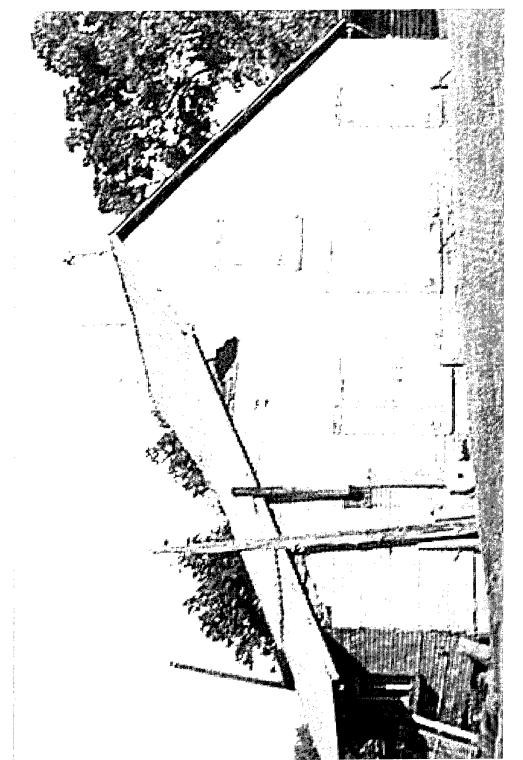
Figure 9. Example of leaning air terminals due to improper maintenance of air terminal support.
